## MANA CRUISING CLUB

# PROFESSIONAL REVIEW OF DEVELOPMENT OPTIONS

Report Number: 19NZ459  
Issue: 01  
Date: 11 January 2020

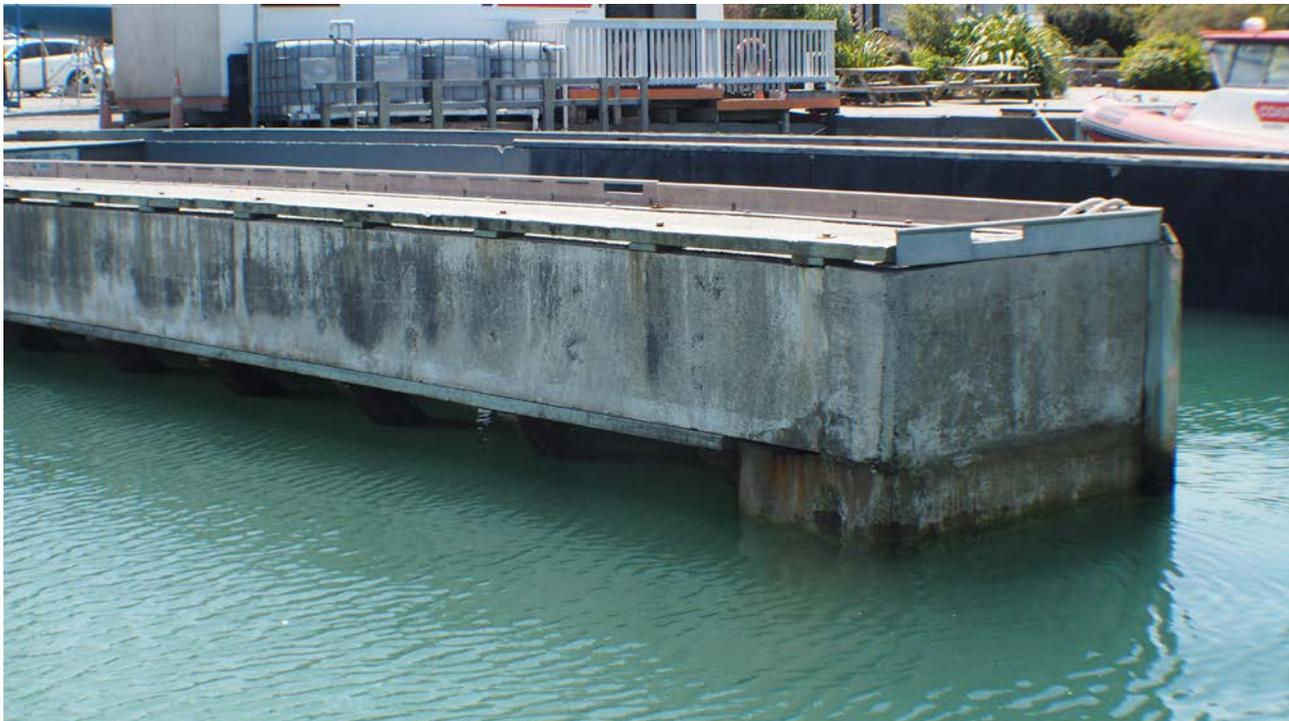
The finger-jetty structure on which the hoist stands for lifting-out is substantial and of encased pile construction. We were advised, but did not test, that the encasement of the piles may be spalding, with re-grouting an option. A slight misalignment of the fingers is also advised, due to settlement, although no present known structural issue. In the experience of Marico Marine, it is often better and more cost effective in the long run to replace this type of construction, than repair. If the misalignment is due to pile settlement, then replacement is a more obvious option. However, we are not structural experts in this area and this opinion is from a brief visit/inspection only and not a survey. Marico have a Dr of Naval Architecture, who specialises loading that a replacement structure would need to be withstand.

**Figure 12 : Lift Jetty Structure Showing Signs of Spalding -Slight Misalignment Reported**

The condition of the cruiser lift finger jetty is of relevance to development decision making. It is reported to have settled and will need attention in the future, irrespective of any development decision.

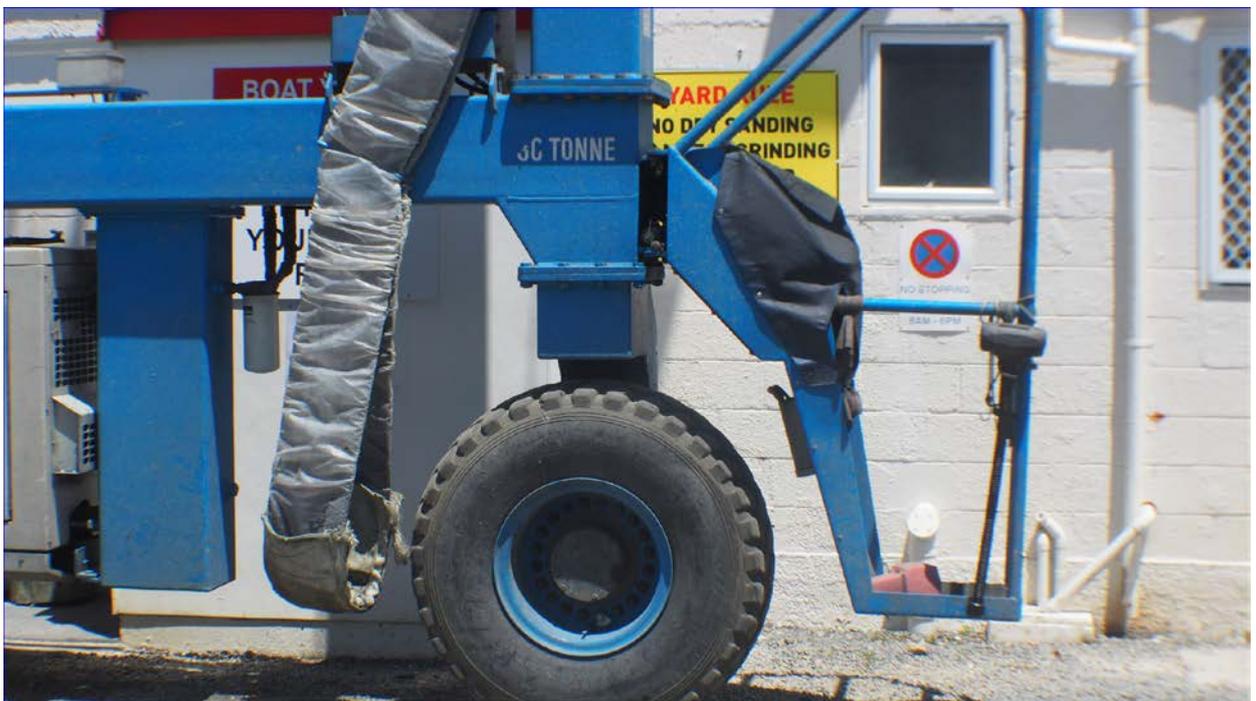
The hoist did not appear to have any obvious Safe Working Load (SWL) markings displayed and in fact still carries a 50-Tonne marking designation, **Figure 13**. As it is lifting gear, regulations require SWL to be clearly marked and we recommend that either a pillar on each side, or a cross member on each side is marked, with its current lifting capacity. There is an NZ Department of Labour approved Code of Practice for cranes which should be referred to. Maritime NZ marine marking rules may also apply, which Marico can assist with.

**Figure 13 : Mana Cruising Club Hoist – SWL Markings Need Clarifying**

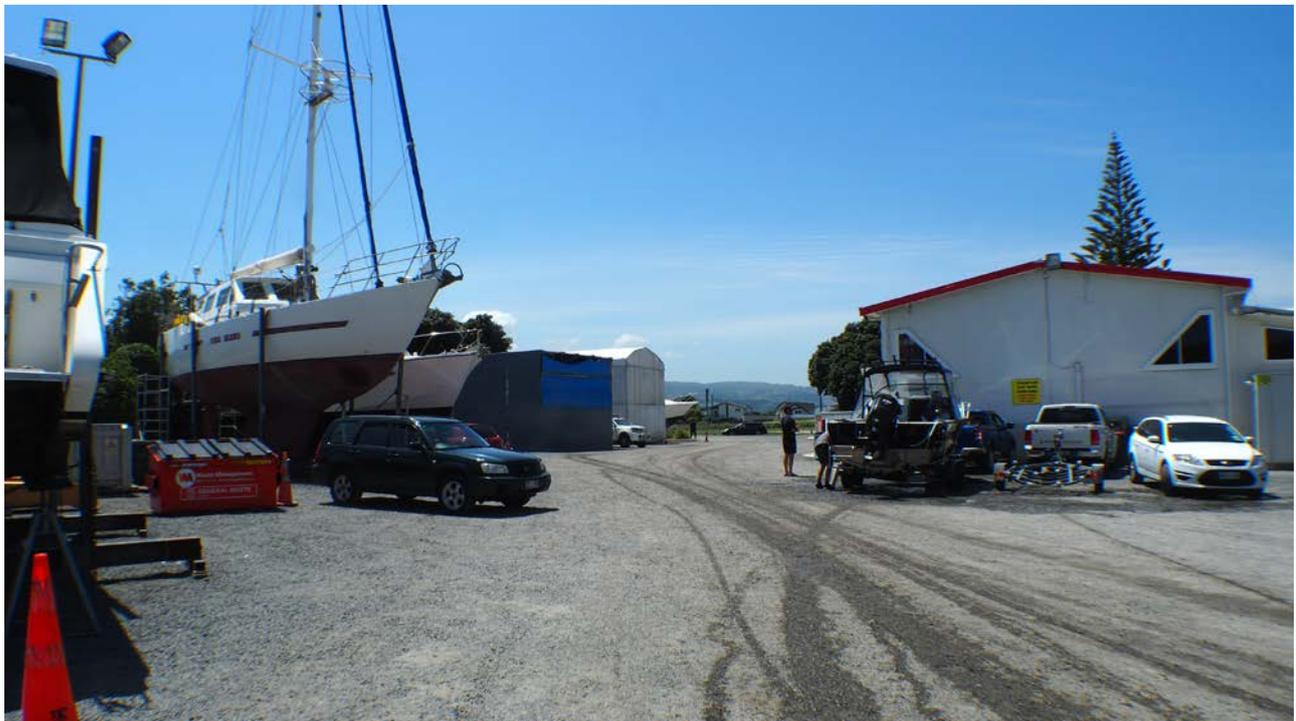
**Figure 16 : Access is tight with Cruisers Stored Alongside the Site Boundary**

The area surrounding the rear of the club house provides the access to the craft launching areas. Cruisers that have been hauled out are stored along the rear perimeter fence, some being worked on and encased in a dust-tents, **Figures 17 and 18.**

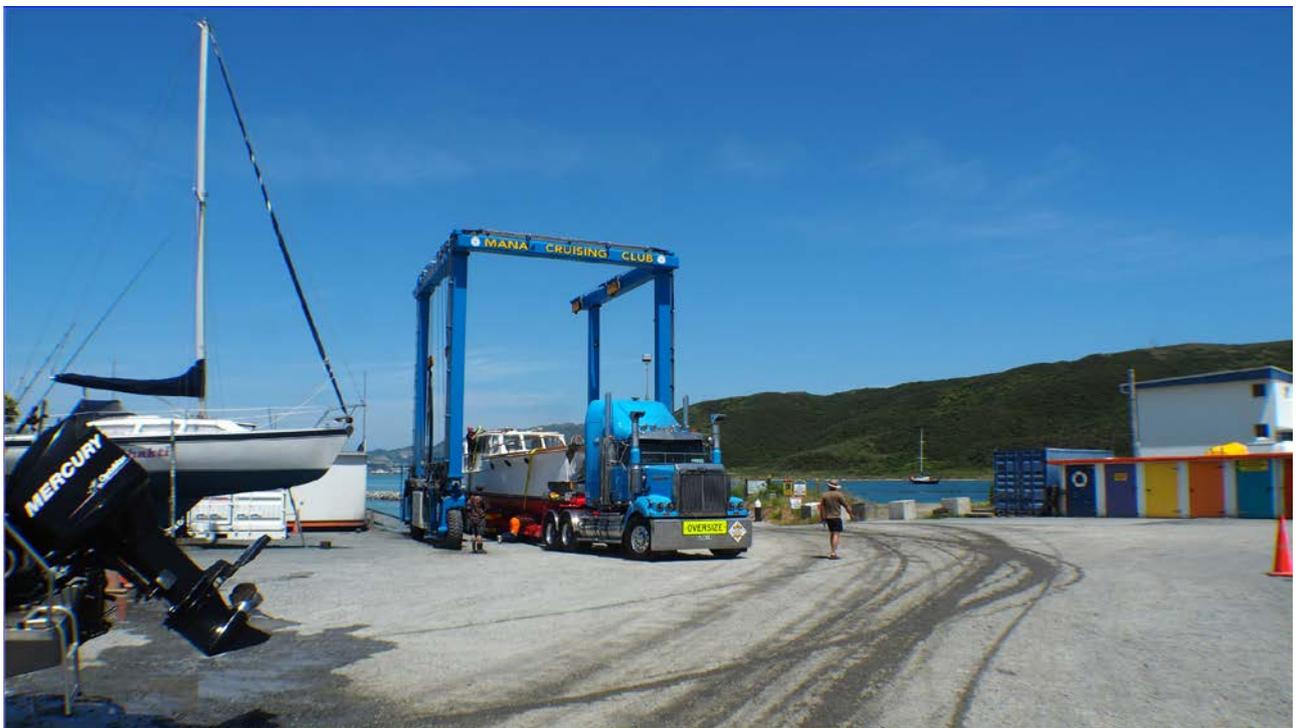
Both the ramp and the boat hoist were noted to be continuously busy on the weekend morning/lunchtime that was observed. **Figure 17,** shows that when cruiser hoist facility is used with a cruiser preparing to be transported by road trailer, there is enough space for this one transit to take place and possibly one trailer to launch. Time is needed for the boat hoist lift operation, which practically should prevent a second craft movement, however small. This further limits trailer launching operations.

**Figure 17 : Vessels Being Moved for Highway Transit Need the Area Cleared**

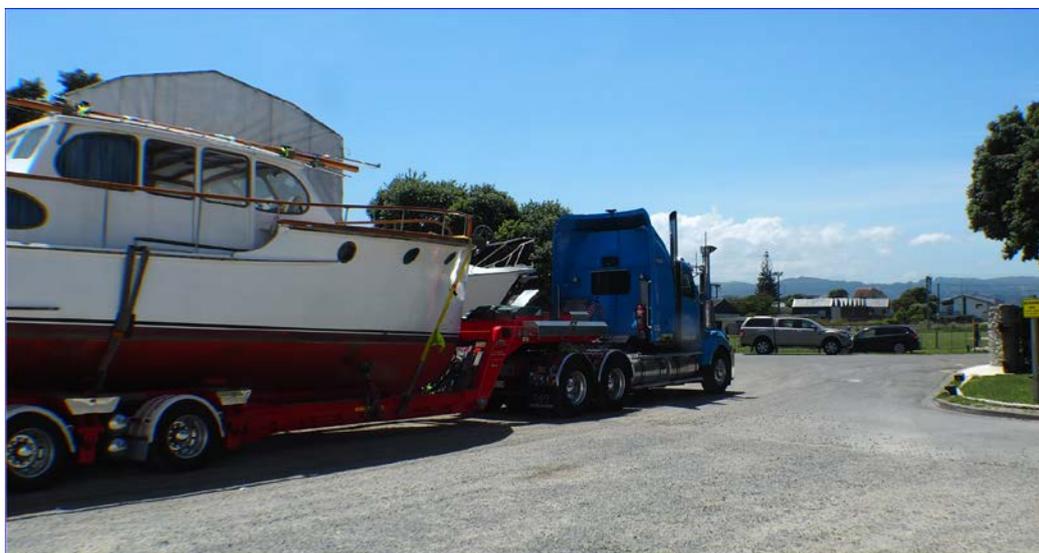
**Figure 18 : Road Jig Being Prepared for Transit - Leaves Little Room**

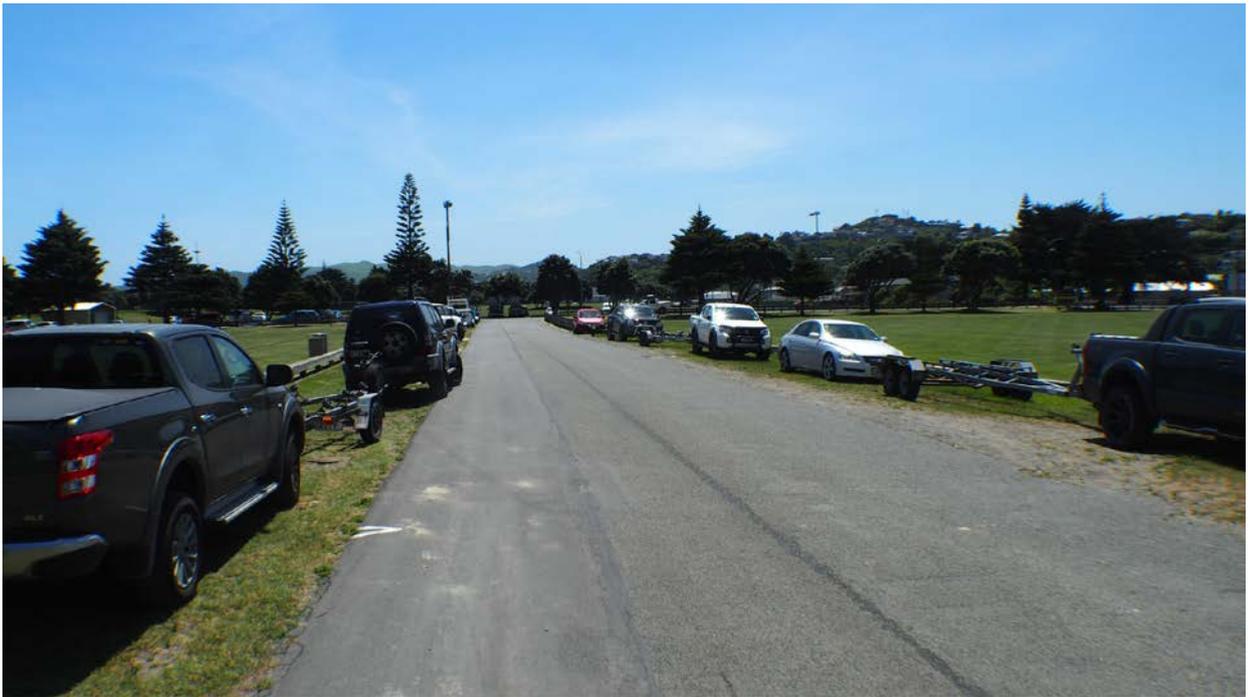
The organisation for parking road trailers of launched craft is also somewhat hap-hazard. On the busy weekends attended, including over the Xmas period, trailers and towing vehicles were stacked on the approach road to the club or parked in the hard standing area, **Figures 19 and 20.**

**Figure 19 : Trailers and Vehicles End up Parked Along Entrance Road**

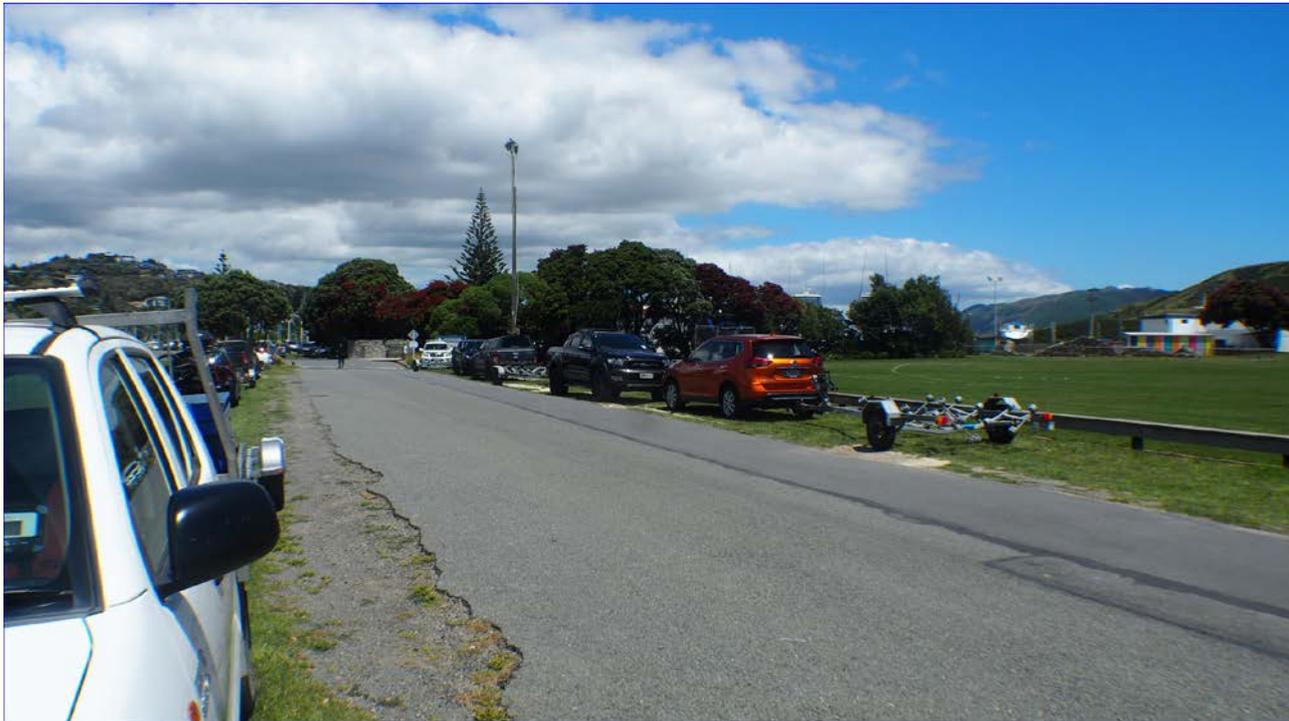
There were 25 cars and trailers counted parked inside the club area. A member reported 28 parked elsewhere on the Ngati Toa Domain on Boxing Day morning. The total of 53 is a significant number and any system needs to plan for its capacity events.

**Figure 21 : Trailers Parked Outside the Club Area - Boxing Day**

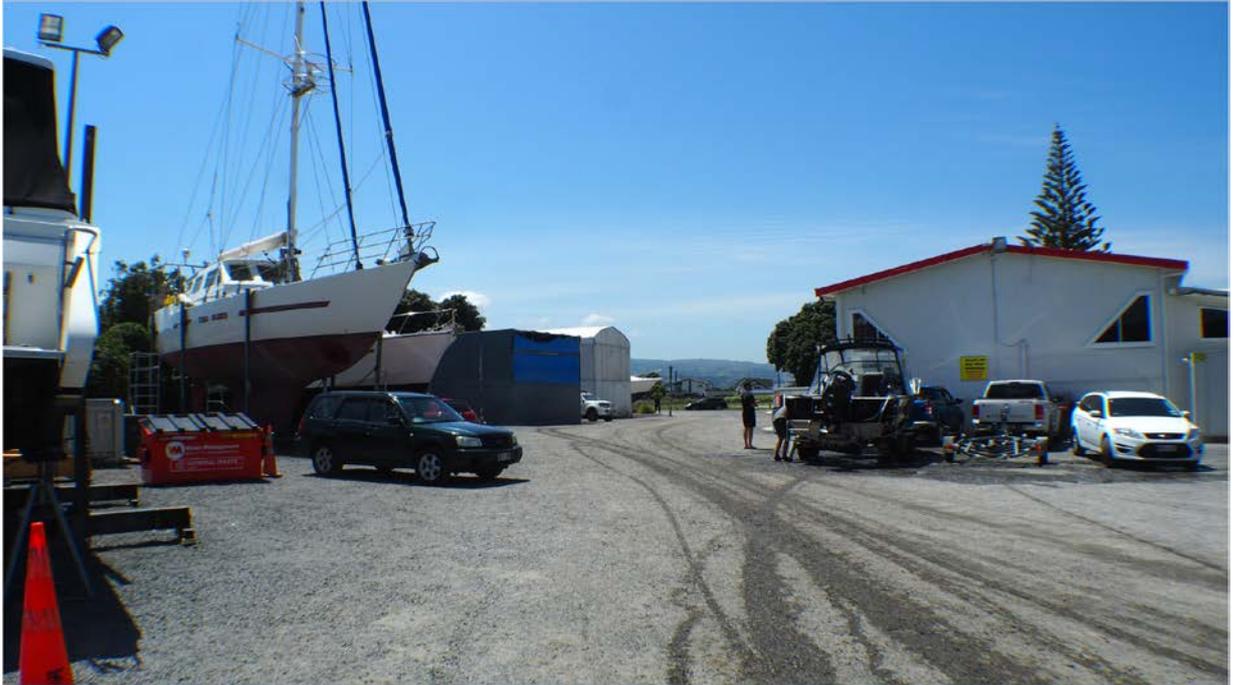
The presence of cruisers in the transit around the rear of the club, including those that have been enclosed to prevent dust from hull stripping operations is taking up space close to the Club, **Figures 22 and 23**.

**Figure 22 : The Launching Area is Limited by Large Craft Stored Close to the Club House**

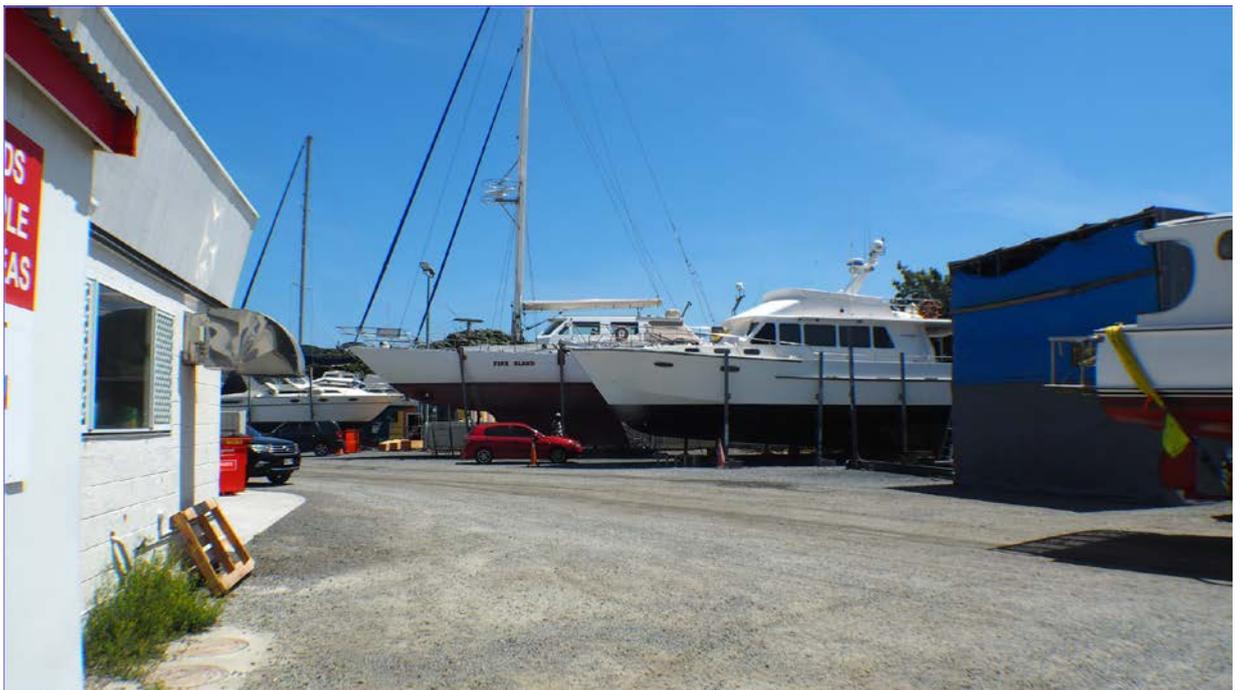
**Figure 23 :Cruisers Stored or under Repair to the Rear of the Club House**
