## MANA CRUISING CLUB

# PROFESSIONAL REVIEW OF DEVELOPMENT OPTIONS

Report Number: 19NZ459  
Issue: 01  
Date: 11 January 2020

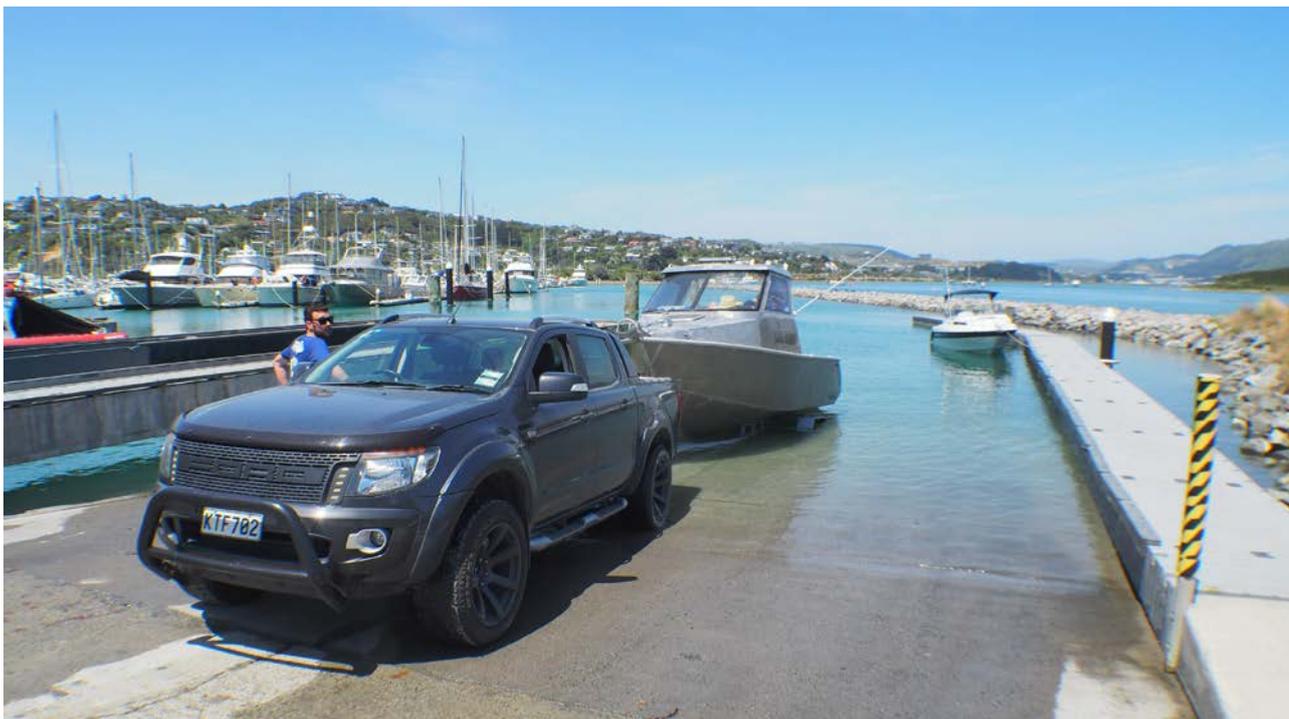
**Figure 10 : Present Launching Lamp is Excellent for Single Launch Usage**

The clubs launching facilities are presently adjacent to each other. The launching ramp is excellent, with an approach angle that allows the vast majority of trailered craft to be launched without vehicles entering the salt water, apart from tyres. **Figure 10**, shows that ramp-room for single launching is excellent. However, on a busy summer’s day the ramp is in almost constant use. On the starboard side of the ramp, there is a floating pontoon with rubber-sheet fendering, with sufficient length to allow launched (or waiting) craft to be placed alongside as they are readied to head-out, or to be recovered. The pontoon has a useful dog-leg at the end, which turns to align with the rock armour wall of the marina enclosure, and thus the channel to the marina enclosure sea entrance. With craft being launched into the marina, there is no chop or wave action, making the launching operation safe for those with limited experience. The ramp itself appeared from a brief inspection to be in good serviceable condition. Its location is excellent, aligning with the marina access channel.

Craft were waiting to use the ramp on the busy weekend and Boxing Day witnessed, especially in the morning. There is little doubt that a double lane ramp would be more efficient for launching and retrieval. A cost-effective way to achieve this would be to recognise the good condition of the present ramp and simply extend it into the adjacent area, and provide a buffered landing pontoon on both its port and starboard side. There are some good on-the-water safety reasons to consider this option further, which are explained later. In order to deliver this marginal change, the finger jetties for the cruiser hoist would need to be moved.

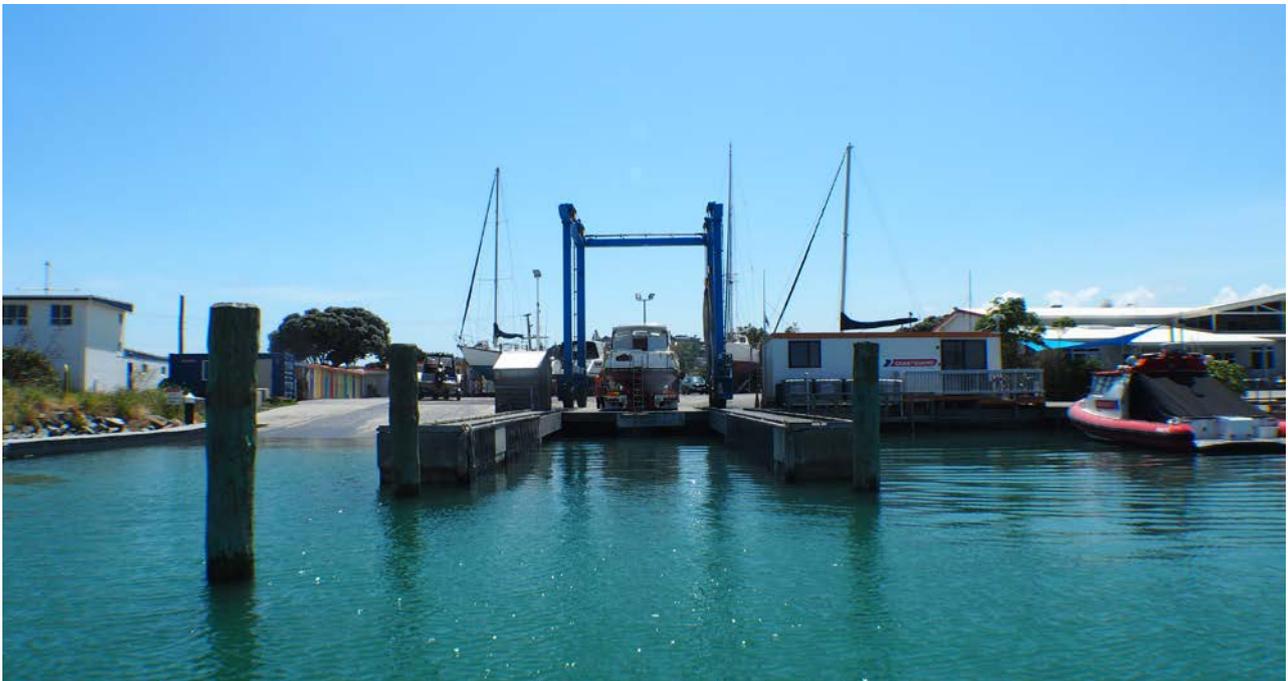
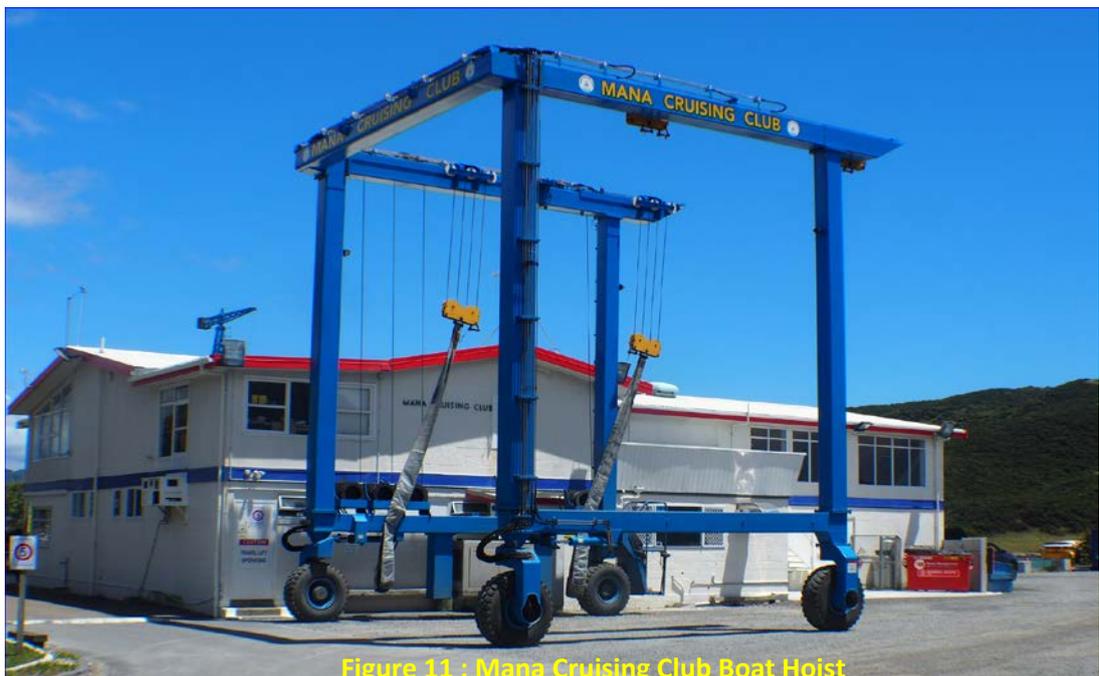
Figure 11 : Mana Cruising Club Boat Hoist

The boat lift is a real asset to the club. It was reportedly originally a 50 tonnes capacity unit, then owned by Team NZ, which was heightened to accommodate their needs and de-rated to 35 tonnes (16 metre) as its height was increased. Even so, is likely to have capacity to lift out most of the cruisers in the marina. It is understood this was purchased from Team NZ. This purchase was, without doubt, prudent. The lift can move the larger craft to any of the boat park areas, although this process will be slow – these hoists are mobile by design, to move a vessel off the water and onto a trailer or cradle. Transporting a cruiser very far is not recommended

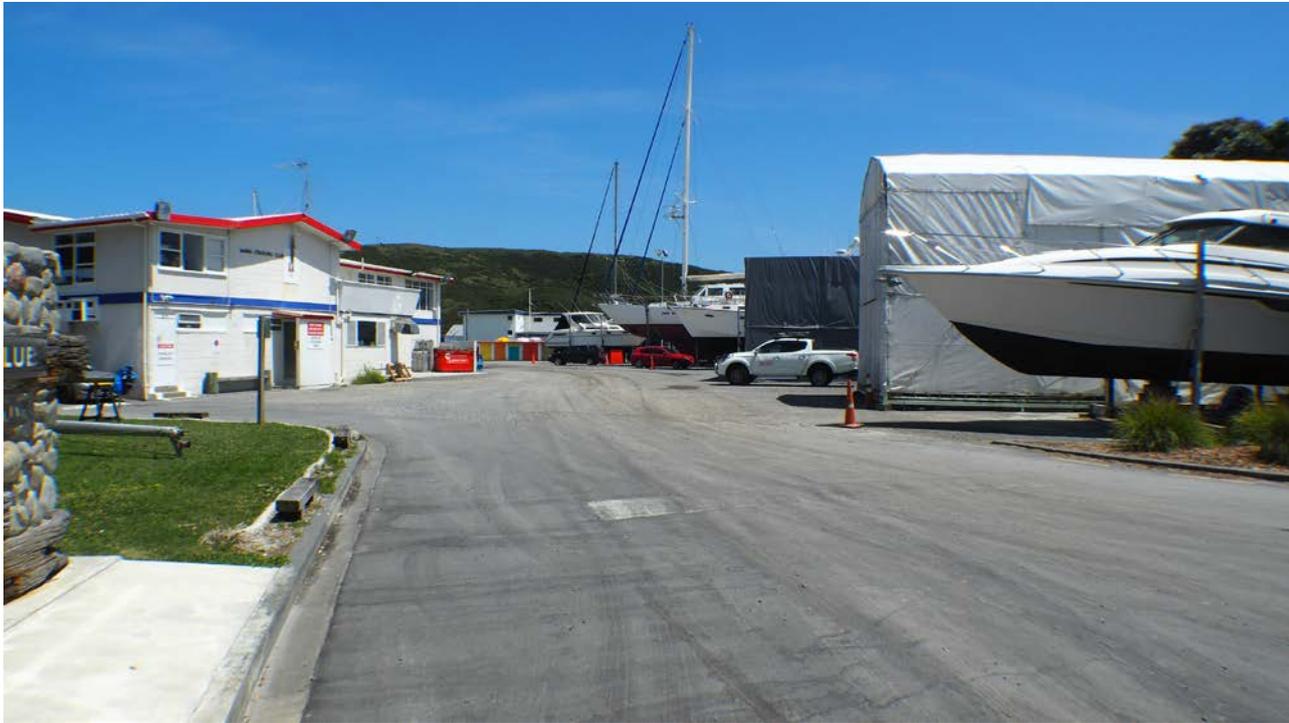
**Figure 15 : Launching Facilities are Approached via the Clubhouse Rear**

The launching areas are approached to the right of the main entrance to the Cruising Club, **Figures 15 and 16.**

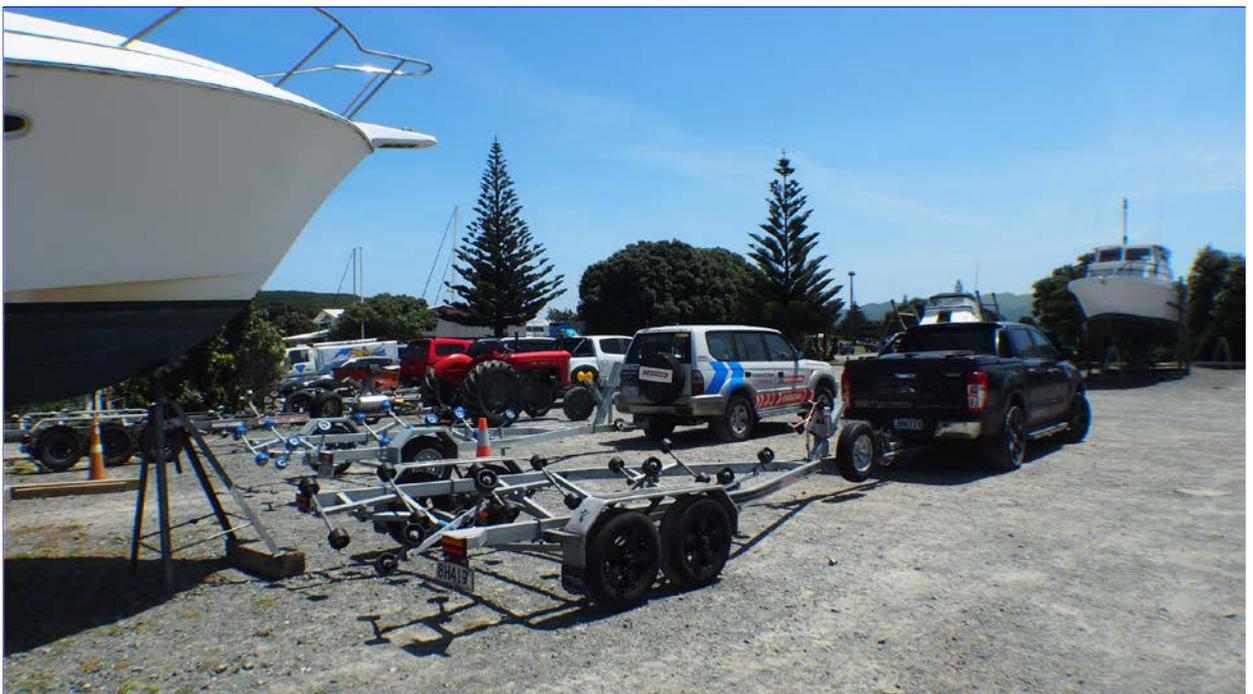
**Figure 20 : Trailers Parked in Hard Standing Area**

The organisation for parking road trailers of launched craft is also somewhat hap-hazard. On the busy weekends attended, including over the Xmas period, trailers and towing vehicles were stacked on the approach road to the club or parked in the hard standing area, **Figures 19 and 20.**

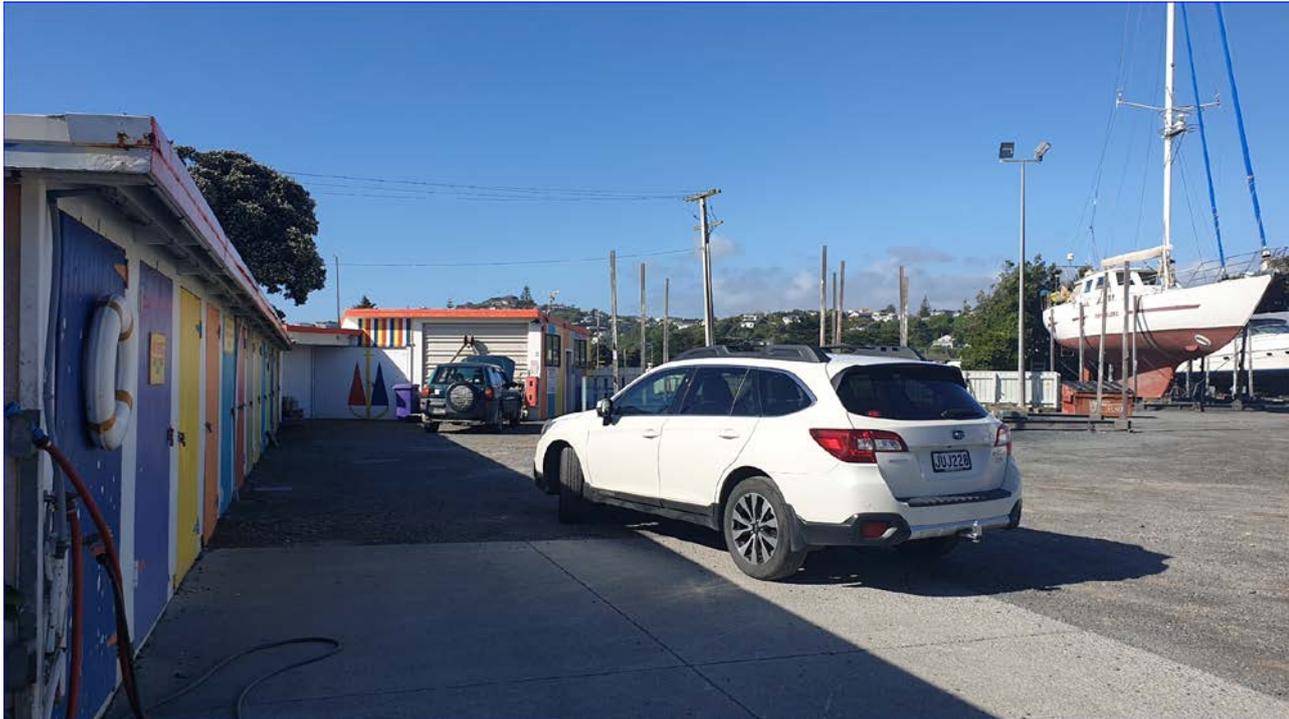
**Figure 24 : Small Craft Storage Garages**

There are small craft and other storage garages adjacent to the launching ramp. As the users of small craft will always launch by ramp, the garages need to be sited adjacent to the ramp, **Figure 24**. They are.

The ramp is also close to the garages for the small craft, **Figure 24**, all of which need the ramp to launch. Moving these to a new location has little cost benefit and as they are already aligning a boundary; the garages are already in a very good location (next to the ramp) for launching small craft.

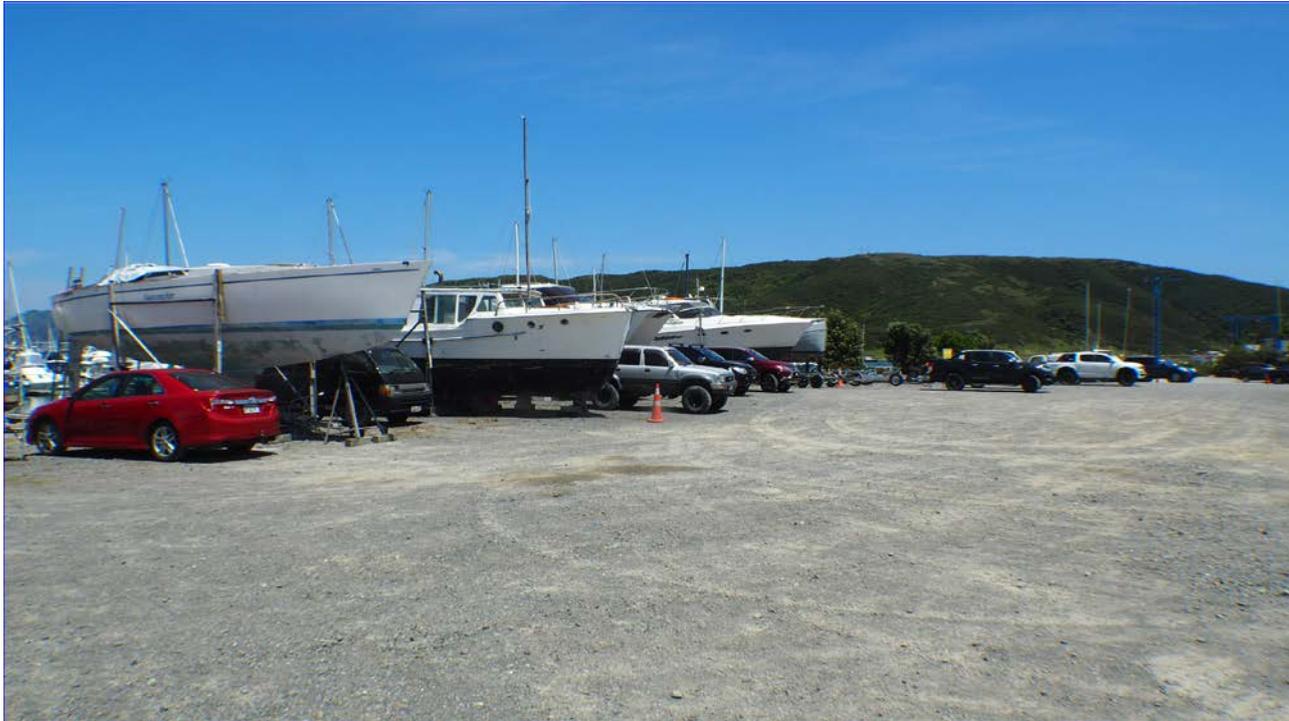
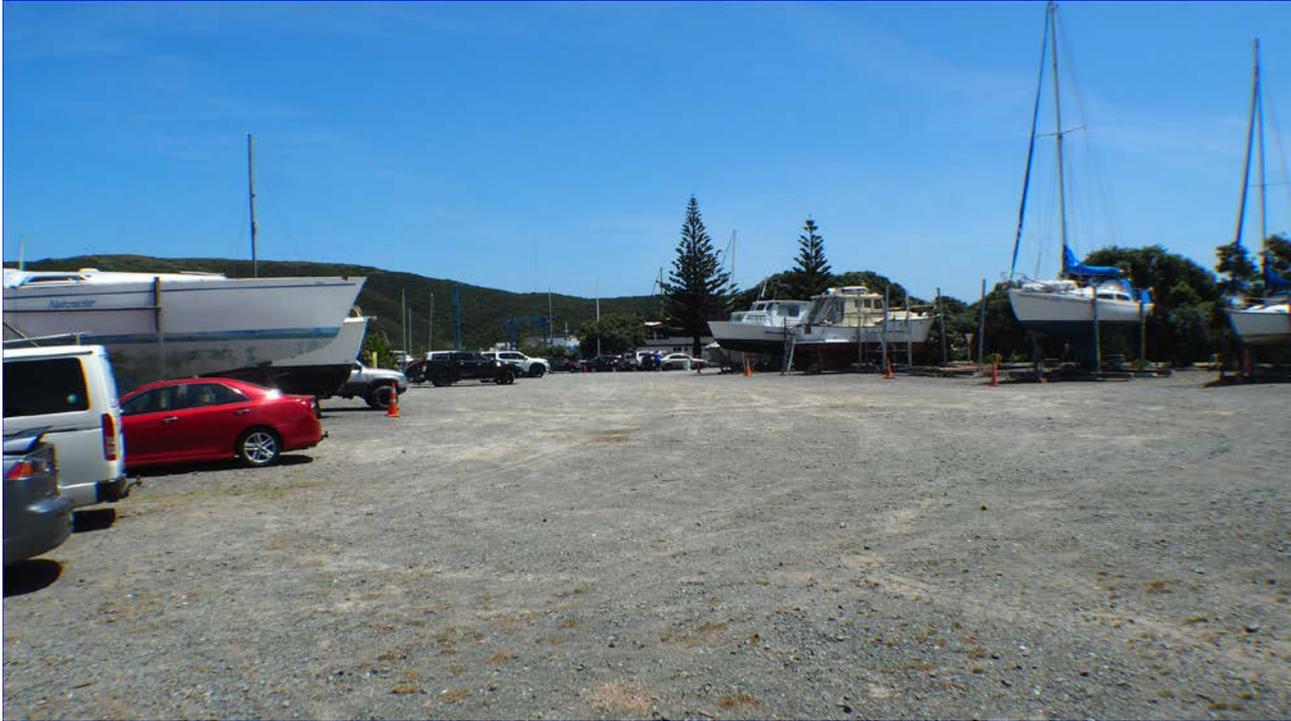
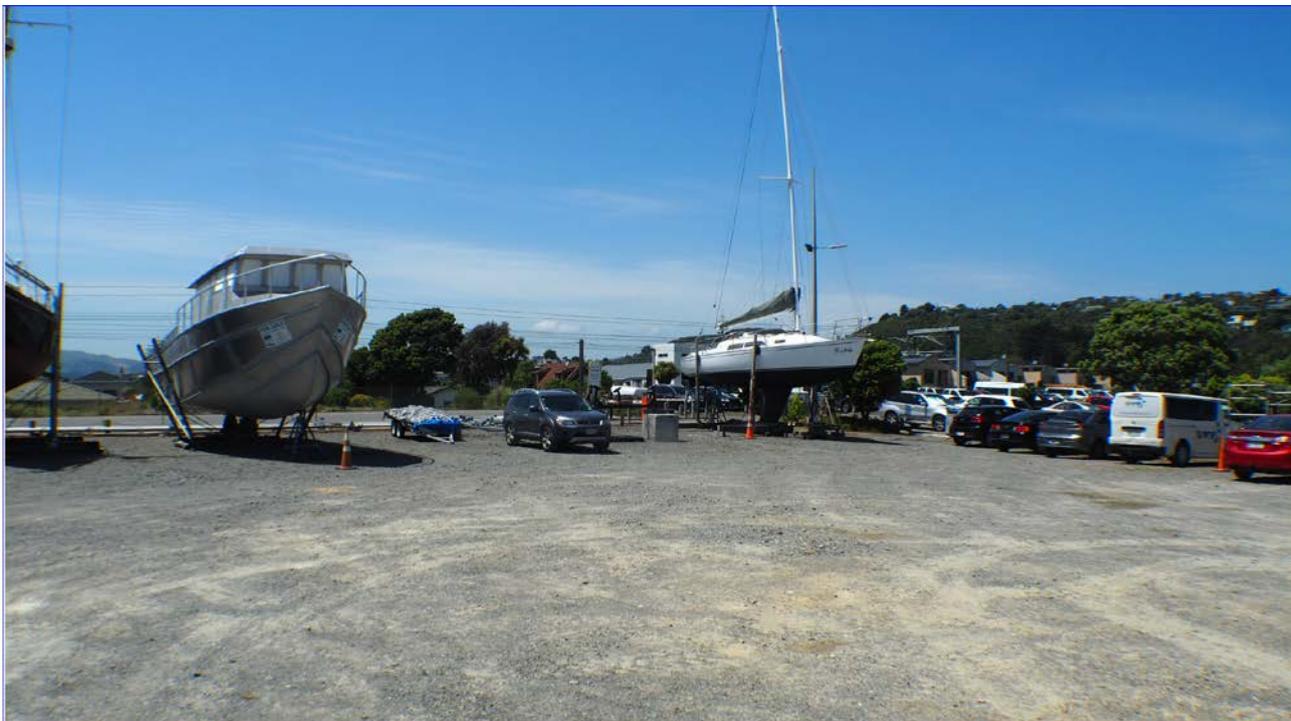
The club has a large area for members that own cruisers to be able to either store or work on their craft. The extent of this is significant and it is an attractive asset to boat owners for obvious reasons. It is also used for the parking of trailers and towing vehicles after launching. This area has an open space that is not really organised. Cruisers having work done to hull coatings are parked in varying locations and a new hull for sale is stored on the site. Whilst all vessels will no doubt be paying fees, organisation of the space could be improved. It is noted that there is no obvious washdown facility for the collection and disposal of hull coatings after being removed, although it was noted that a number of vessels being worked on were properly tented over, providing a full environmental enclosure.

**Figure 25 : View of Large Vessel "Utility" Area**

The club would benefit from a reorganisation of this space and parking in general. Importantly, with a reorganisation, it could also build a hull wash down facility that implicitly capture hull coating paint chippings for environmentally beneficial disposal.

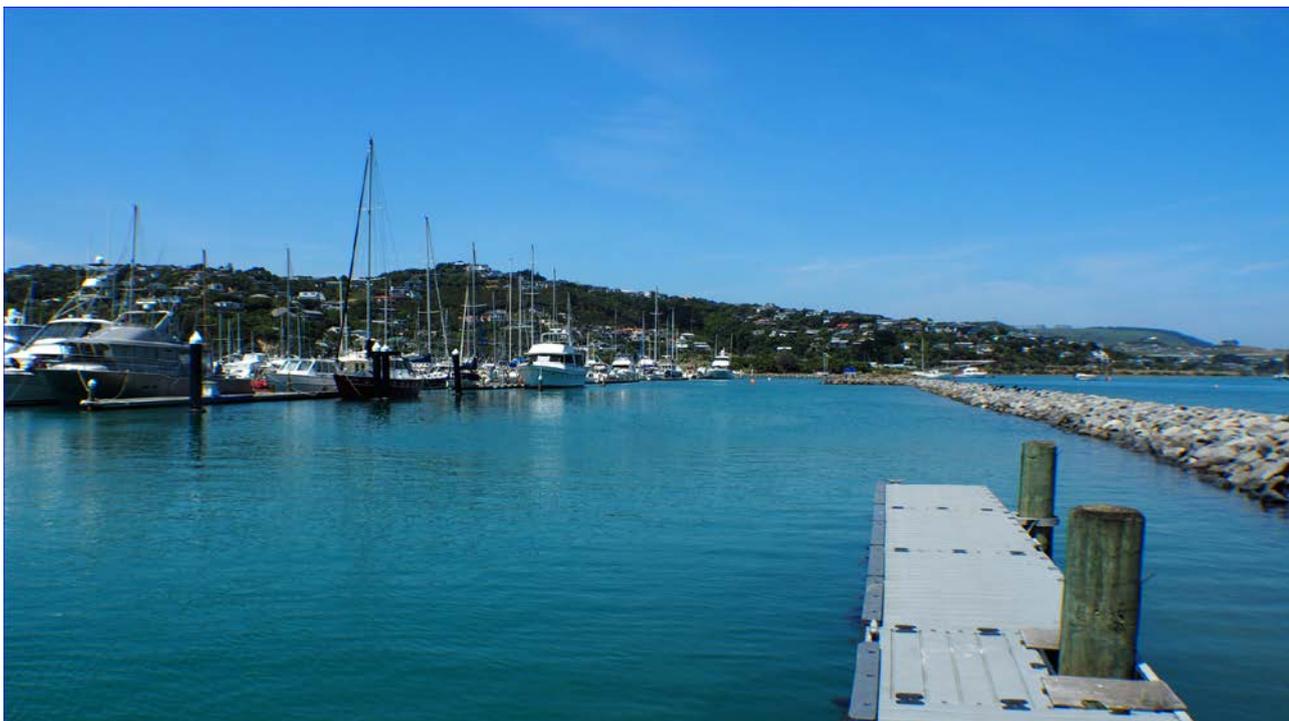
**Figure 28 : When Launched Trailered Craft are Aligned With Marina Exit Channel**

The trailer launching ramp is in a location with important navigational safety aspects, inherent in its location. By far the greatest frequency of launch and retrievals are associated with trailer launched craft, so they also dominate the number of movements through the marina in any one year. When they are launched, the location of the ramp has craft aligned with the starboard side of the marina access channel. An outbound craft, after occupants have boarded at the jetty, is set to follow the navigational rules of the road, proceeding outbound on the starboard side of the channel. They are presented with a safe and straightforward exit route, **Figure 28**.

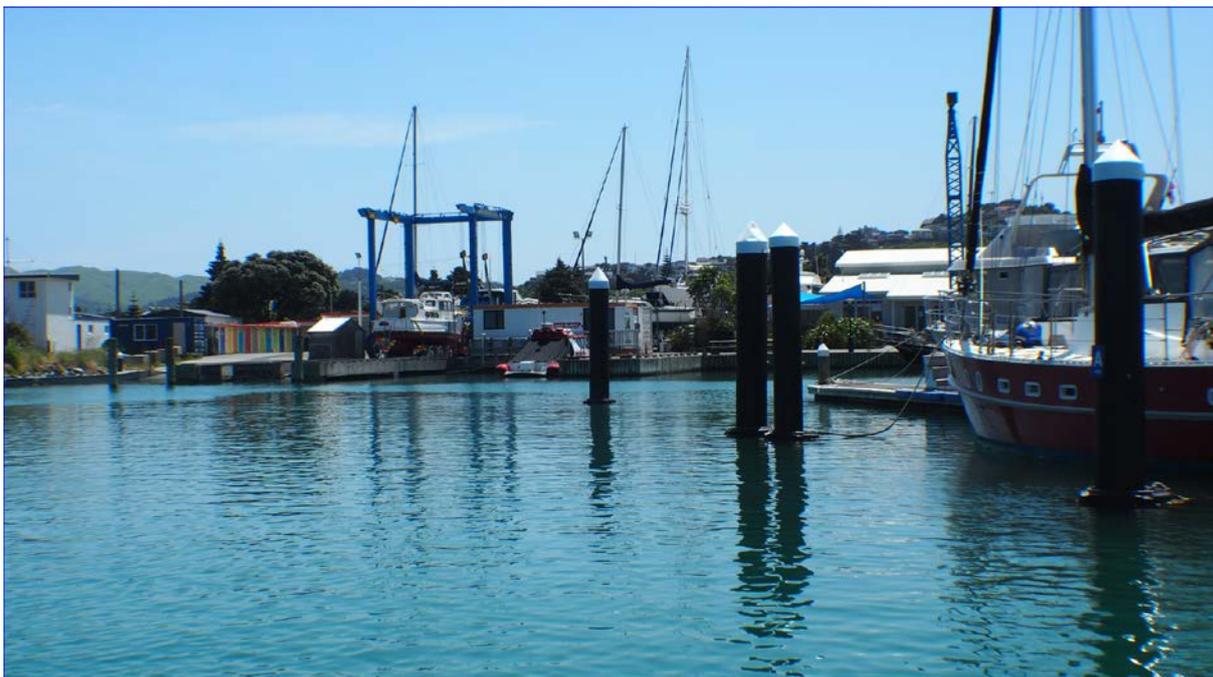
**Figure 29 : Perspective of an Inbound Small Craft**

When a small craft is inbound on the correct side of the marina channel, it has limited visibility of any craft present in the waterfront area, right up to the point where it would have to turn to starboard to enter the waterfront area. A craft heading outbound on the wrong side of the channel is very common amongst recreational users, presenting one of the well-known and acknowledged safety hazards of the necessary square layout of a traditional marina design. **Figure 29**, taken from a small craft in the water demonstrates this. It is not possible for occupants to see over the pontoons to become clearly aware of any craft proceeding out of the Club waterfront area. Speed through the water is limited by rule, which mitigates the consequences of any collision. There is also a good sea room for manoeuvre and separation in the Club waterfront area, **Figure 30**. Nevertheless, it is a classic marina collision scenario; almost all marinas possess a 90 degree swing at some part of their design. The larger cruisers have the height to have visibility around the corner of the marina, as they have when proceeding out of one of the berth-pen rows.

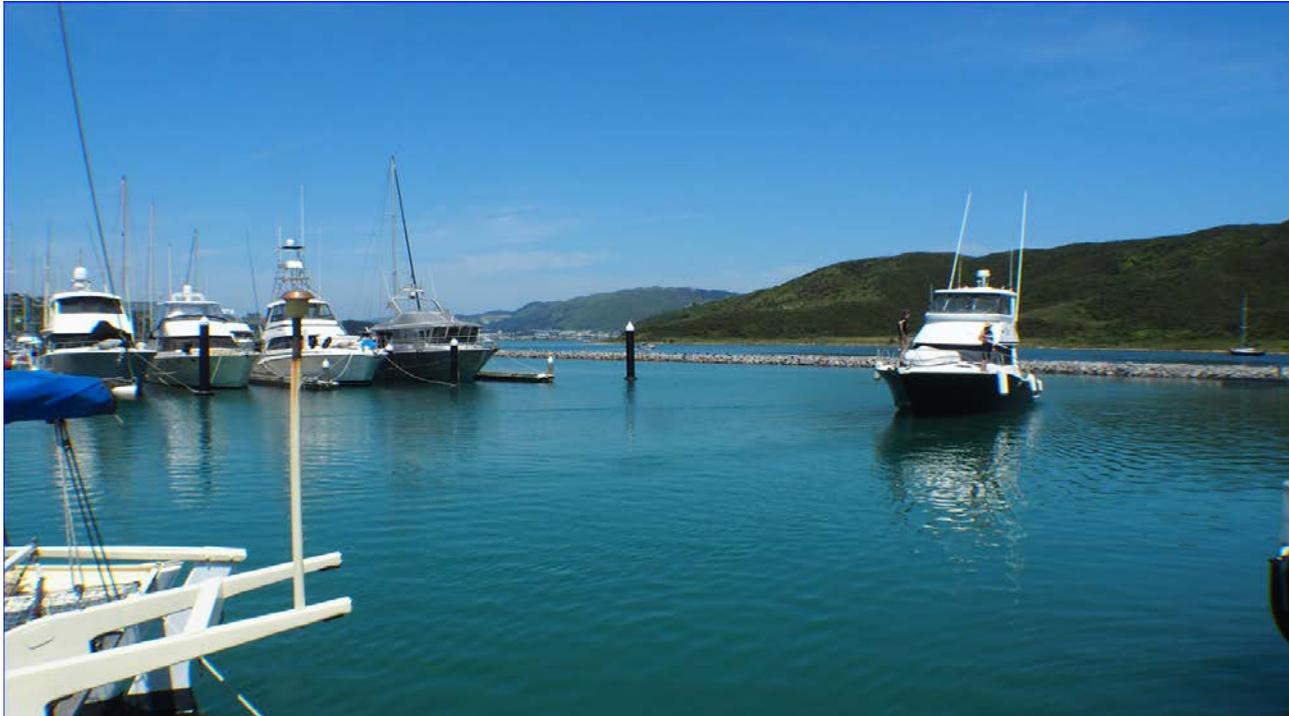
**Figure 31 : The Cruisers have a Visibility Height Advantage for the Marina Corner**

The present design layout of the trailer-craft launching arrangements is thus following principles of good marina layout design, which in this case very good. Moving the ramp from its present location would in the view of Marico be a backward step and perhaps inadvertently introduce a collision-safety issue onto the water, that is presently inherently mitigated. This factor becomes more important when the facts of the relative transit numbers, between large and small craft are taken into account. Our opinion is that there must be a greater number of trailer-craft movements, but club members might know otherwise. In any event, the larger craft simply have better visibility. The logic is further grounded when facts of the future growth potential of the club are also considered. With the Marine full and expansion unlikely, trailer craft membership is the obvious area for future growth.
